## HYDROGEOMORPHOLOGICAL RISK ANALYSIS MODELS IN EXPERIMENTAL RIVER BASINS. CASE STUDY: BĂICENI-CUCUTENI MUSEUM GULLY (OII VALLEY WATERSHED)

**Abstract.** Analysis models proposed in this paper represent a part of the results obtained from monitoring of the hydrogeomorphological risk potential identified in Băiceni – Cucuteni Museum gully. This activity started in 2008 when a series of detailed morphometric measurements were performed with high quality instruments. In 2010 were added some hydrometric measurements, which are designed to predict potential risk events associated with the maximum flow occur. The monitoring process is still carried out to detect morphology dynamics at seasonal, annual and multiannual scale. Our objective is to propose a model that can be extrapolated to other experimental river basins with small dimensions. Also, the results obtained wish to support any dispose plans of this area in order to efficiently reduce the risk caused by accelerate erosion and possible overflows.

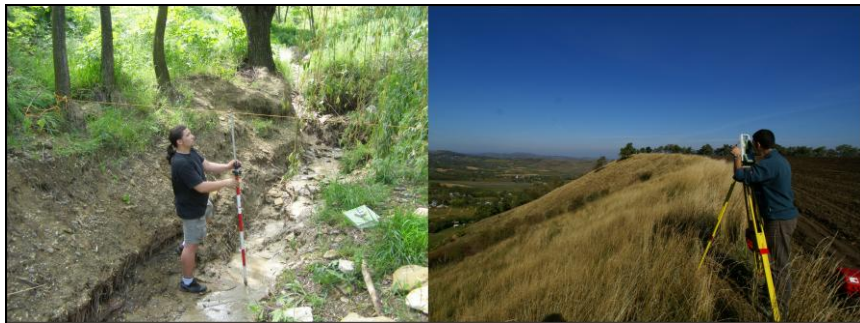
Figure 2: Hydrological and geomorphological total station measurements

To point out gully dynamics, and especially above the main gully thalweg evolution, relating to the two flanking banks but also measurements regarding negative events associated with maximum flow, we used modern instruments like Leica Total Station TCR 1201 (figure 2), orthophotoplans from 2005 and the field observations. Gully measurements started since 2008 when was realized first detailed DEM 1:500 m scale; these measurements will continue for the thalweg and gully banks. All measurements are in STEREO 70 projection system (Romania's official projection system). Points measured with total station have been overlayed on the orthophotoplan to track thalweg dynamics (figure 3). For data processing we used ArcMap 9.3, AutoCAD 2008 and Microsoft Excel software.

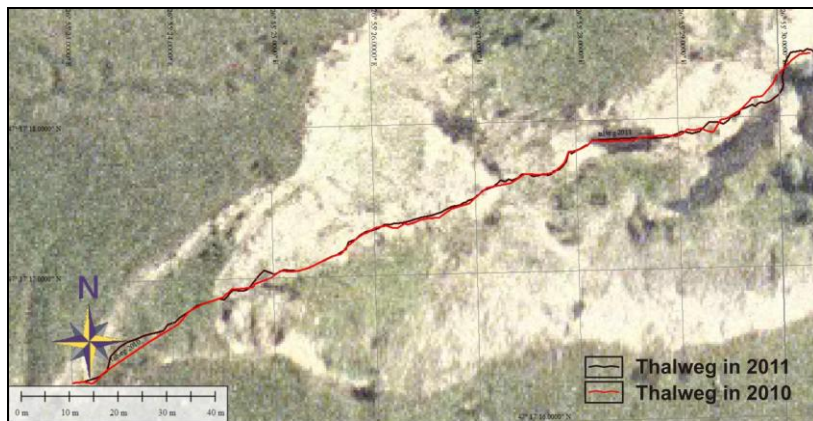
Fig. 4: Main gully thalweg evolution between 2010 and 2011

After a series of measurements performed with the Total Station on the changes for the thalweg dynamics of the main gully, we can observe a change in the upper part of the thalweg with a deviation of about 2.6 m from SE towards NW, in the middle part with deviations not large than 1 m and near the junction with the second's gully thalweg with deviations from 1 to 2 m; in the middle part and the final part of the thalweg deviations come from NW towards SE (the slope is affected by a landslide, fig. 4)

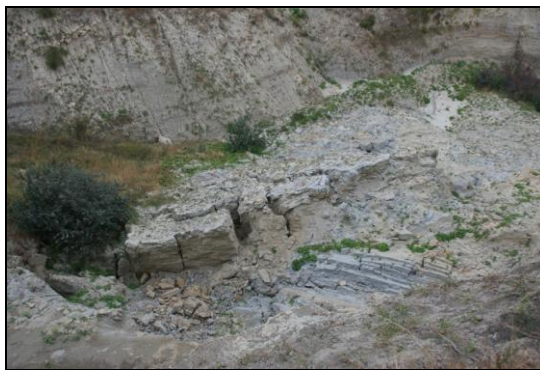
Figure 5: Dislocated material from the main gully bank sliding in the thalweg

These deviations are a cause of the dislocated material from the upper part of the right bank of the gully (figure 5) which has deposits on the thalweg level. Although a significant volume of material has been displaced, our predictions for thalweg change in direction were not quite confirmed; this is because of a coast stream with a strong enough flow (especially during the summer when torrential rains occur), but also a high slope which supports the deposited material transfer (clays and sands mainly) outside gully perimeter.

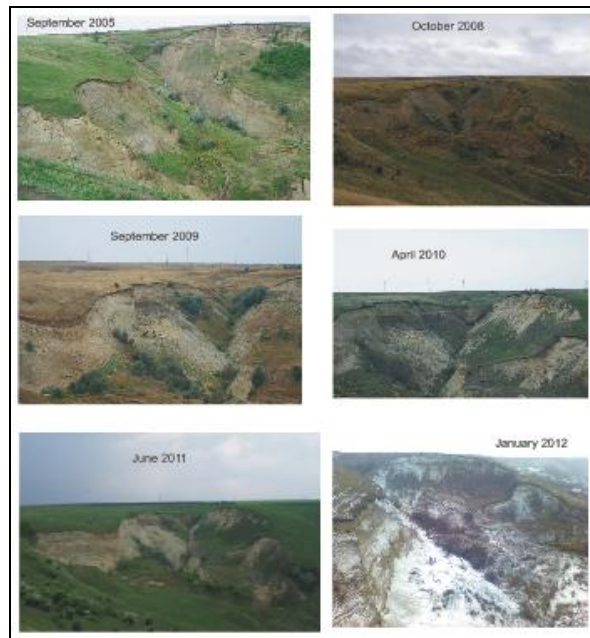
Figure 6: Main gully sector dynamics along a 7 years period

Along with field measurements to point out erosion amplitude we made some suggestive photos in different years and seasons, who show an intensive erosion activity (figure 6).

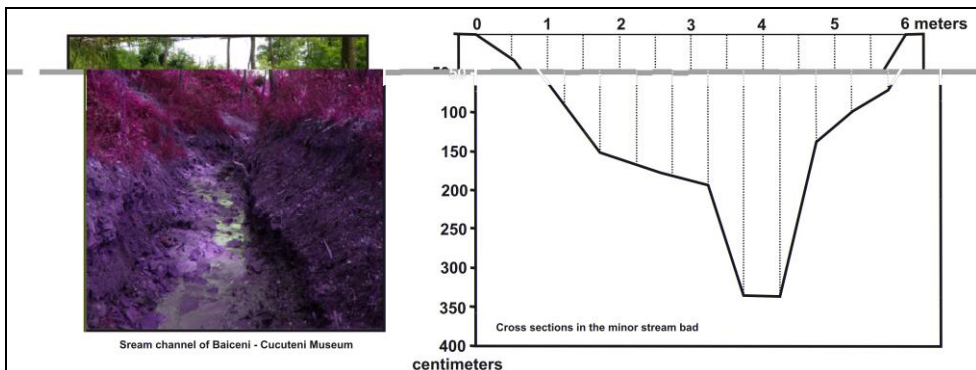
Figure 7: Cross section in minor bed of Băiceni-Cucuteni Museum gully

The torrential character of these phenomena is also influenced by the streams from the base of the banks, thanks to the intense infiltration process. This fact is reflected in the minor riverbed configuration which has relatively high depths for such a small catchment.

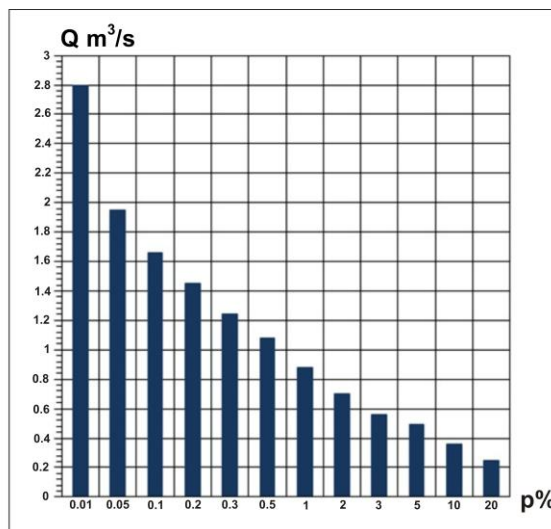
Figure. 8: Maximum flow values based on probability to occur

On the basis of this flow with probability of exceeding of  $Q_{1\%}$ , we calculated the maximum flows with different probabilities (table 2).

p%	0,01	0,05	0,1	0,2	0,3	0,5	1	2	3	5	10	20
$Q \text{ m}^3/\text{s}$	2,8	1,95	1,66	1,45	1,24	1,08	0,88	0,70	0,56	0,49	0,36	0,25
