Risk maps for gully erosion processes affecting archaeological sites in Moldavia, Romania

GHEORGHE ROMANESCU and IONUȚ C. NICU

Summary. Most of the archaeological sites in Moldavia are situated on hill borders, at the contact with lower landform units. This is why most archaeological sites are affected by the erosion of slopes, mostly the one caused by gully erosion. In order to realize the topographical measurements of the Cucuteni gully, LEICA TCR 1201 Total Station has been used. Together with LEICA GPS 1200, this station is part of SYSTEM 1200 LEICA. In order to start the measurements, the coordinates of the ground control points were obtained from ANCP Iasi. For data adequacy assessment, we also used the 3D Scanner measurements (6 mm/6 mm resolution). The differences between the two measurements are insignificant, which proves that the Total Station can be used with success at any time. The only shortcoming is that it takes more time and, at the same time, it is very difficult to get on very steep slopes. The Cucuteni gully registers a very fast evolution, as there is an ever growing intensity of pouring rains. The measurements carried on during 2008–2010 have shown that, if

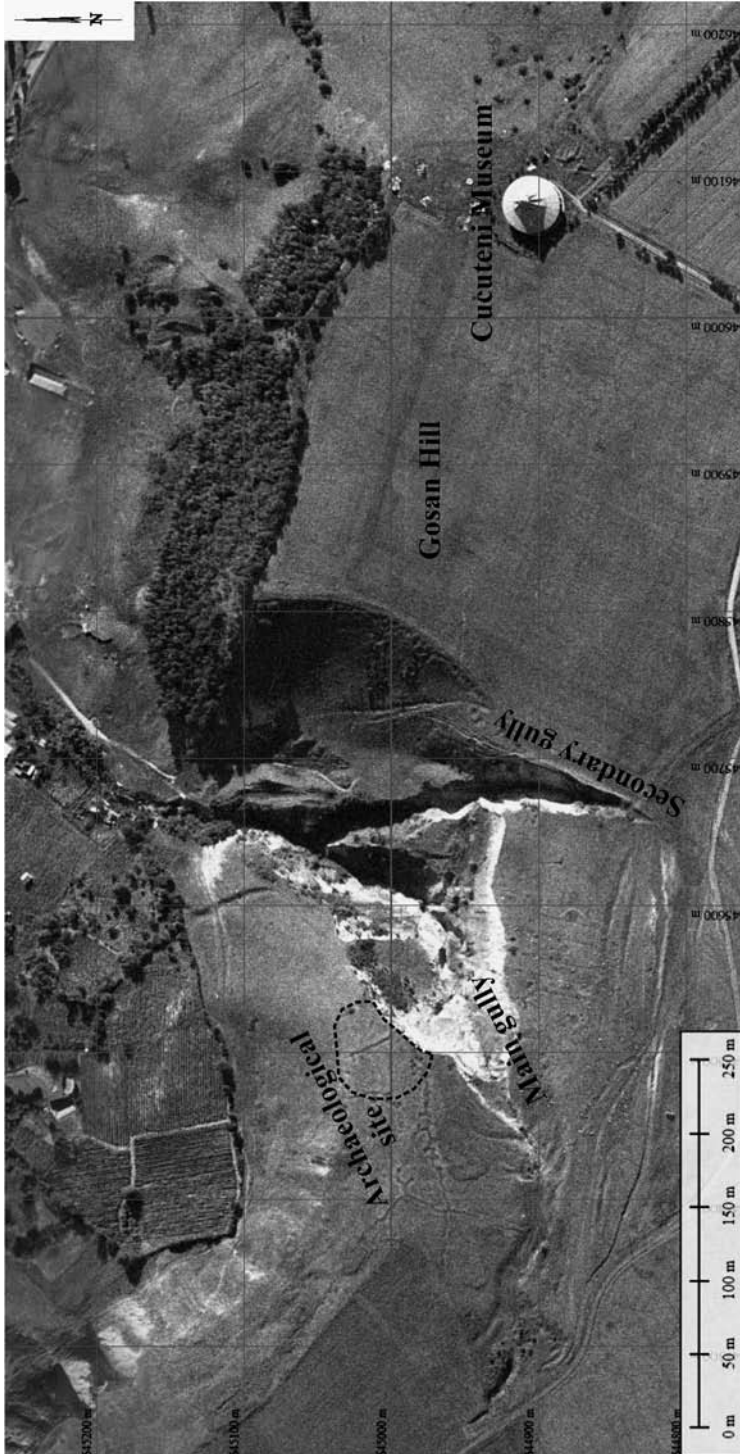
Fig.2. The limit of the Cucuteni gully and of the archaeological site.

We chose to monitor the Cucuteni gully evolution because of its fast dynamics and the fact that it affects one of the most important archaeological sites in Romania: the Chalcolithic settlement of Cucuteni, evidence of a long existence of the population on the Romania territory and eastern Europe (BOGHIAN 2004). At the same time, the Cucuteni gully evolves rapidly because the old forest was eliminated, the slope is steep, the rock is highly friable, pouring rains have ideal conditions to occur, etc. (fig. 2).

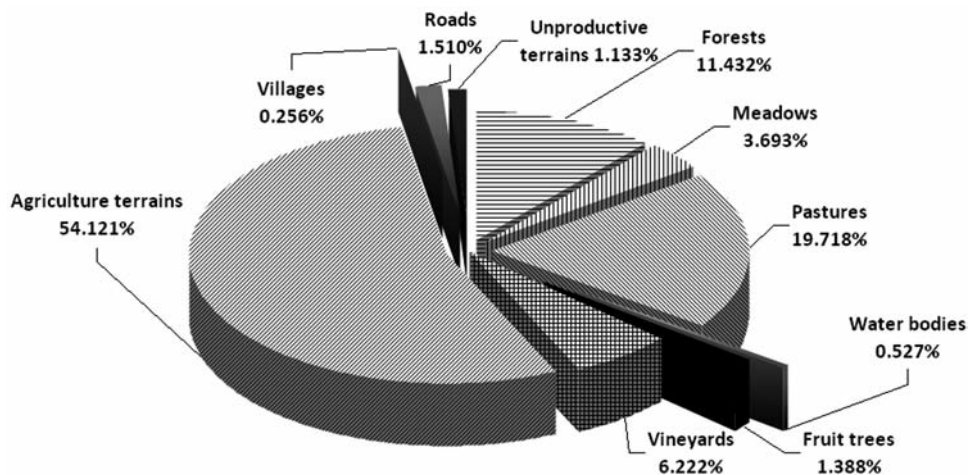
Fig. 10. Land use in the area of the Cucuteni gully.

A very important measure of protection for the studied area aims to change the way the land is used (fig. 10). The area surrounding the archaeological site must be completely forested. Currently, it is mainly used for agriculture.
