Eco-Rehabilitation and Improvement of Water Plant and Animal Species

From 2011 to 2013, in the water area of Kuibyshev Reservoir in the Kazan region (Russia), the artificial plots of land were created in the process of land reclamation. As a result, 600 hectares of flooded islands, breeding grounds, and channels were filled with sand. The system of artificial land plots was formed, connected with the existing islands. And the part of the Volga River, enclosed by them, turned into a relatively landlocked body of water. In the process of land reclamation, the destruction of the water body, fauna and flora of water area and islands was revealed.

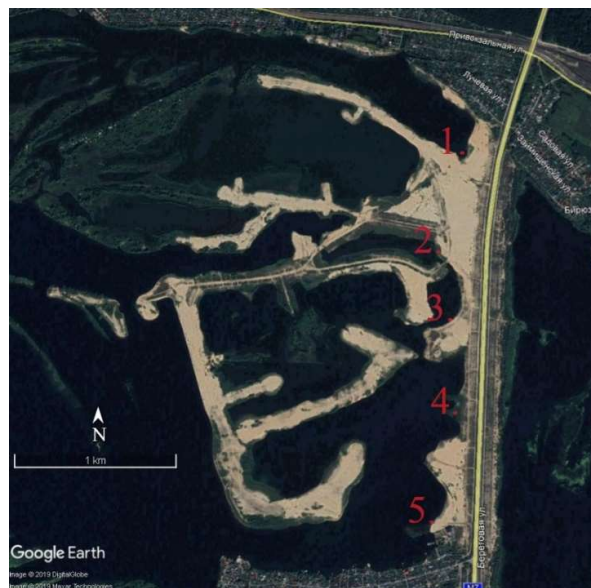
Fig. 1: Sampling Points.

In July-August 2018, the field studies of Kuibyshev reservoir were conducted near the village Zaymishche (Fig. 1). The measurements of physical and chemical parameters of water (oxygen content, water temperature, pH), the sampling of zooplankton and zoobenthos were performed.

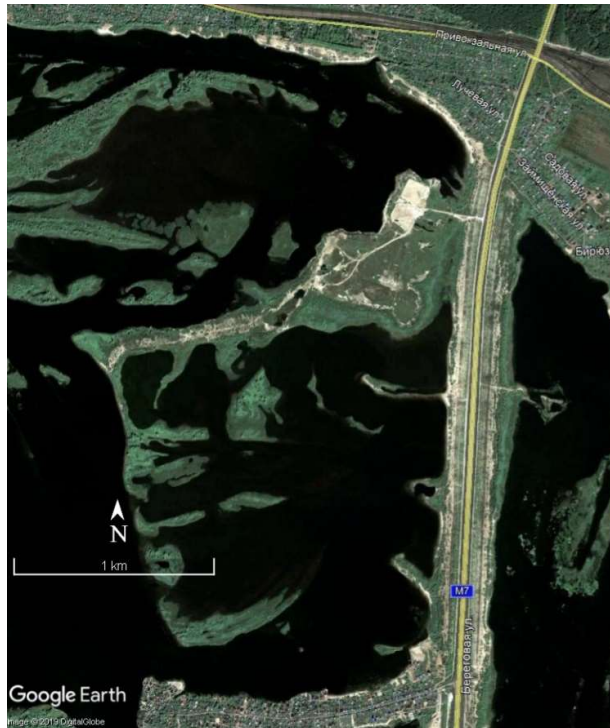
Fig. 2. Space Image, dated August 22, 2009

Due to the measures of environmental activists and the local population, the works were stopped, and the prohibition on the construction of high-rise buildings in reclaimed territories was imposed. At present, this territory is considerably transformed. The space images show the difference between the structure of the river and islands a few years ago, and current situation, after a large-scale hydraulic filling of territories (Fig. 2-3).

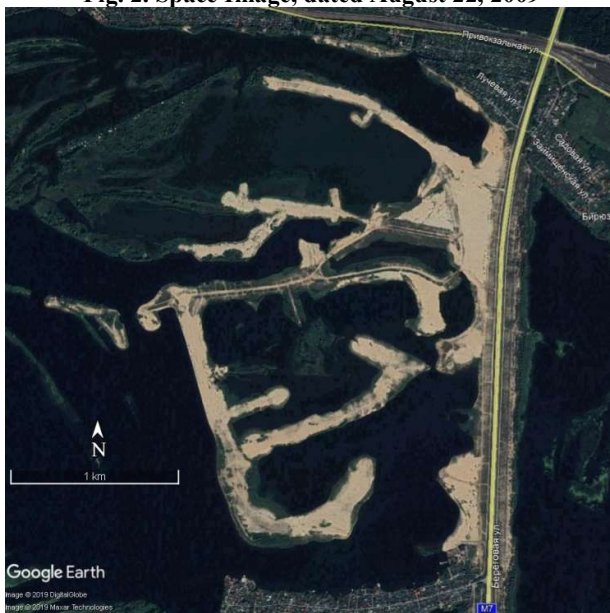
Fig. 3. Space Image, dated August 31, 2017.

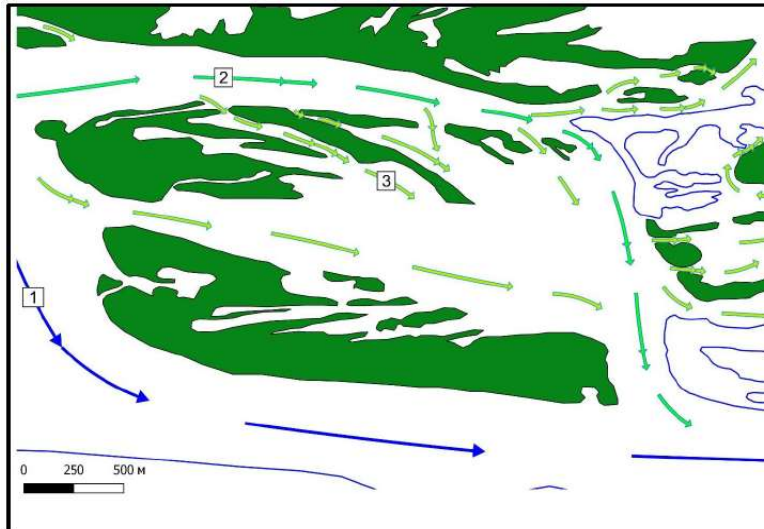
Fig. 4: The Types of Currents in the Studied Area (1 - Midstream, 2 - Subsidiary Flow, 3 - The Currents of the Inter-island Channels).

The features of islands configuration allow to determine the direction of the prevailing currents in this section, with a sufficient degree of certainty (Fig. 4). Before the reclamation of land in this area, three types of currents could be distinguished: 1. Midstream. 2. Subsidiary flow. 3. The currents of the inter-island channels.

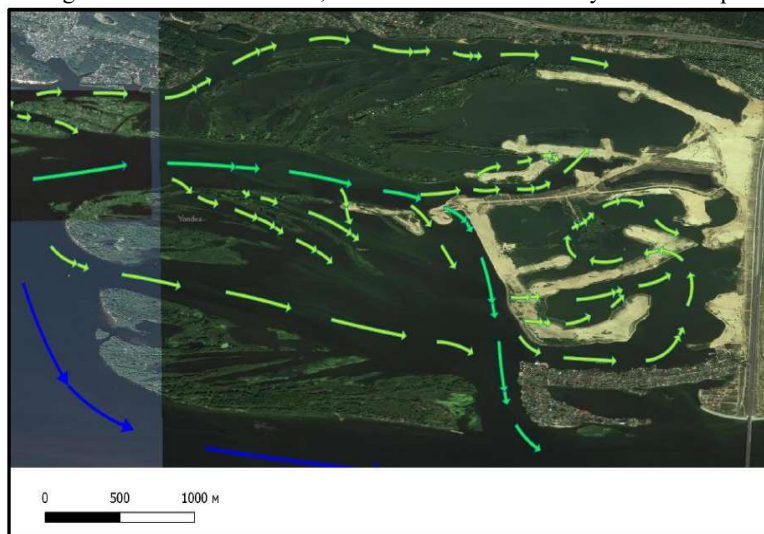
Fig. 5: The Zones of Blocked Water Flows in the Inter-island Channels.

Having laid the image of prevailing directions of the former currents on the space image of the present-day situation (using the program SAS.Planet), the areas, where the land reclamation blocked the existing water flow and changed the ecological situation, can be determined (Fig. 5). Land reclamation changed the circulation of water in the channels between the islands, forming isolated bodies of water, which are characterized by low water quality.

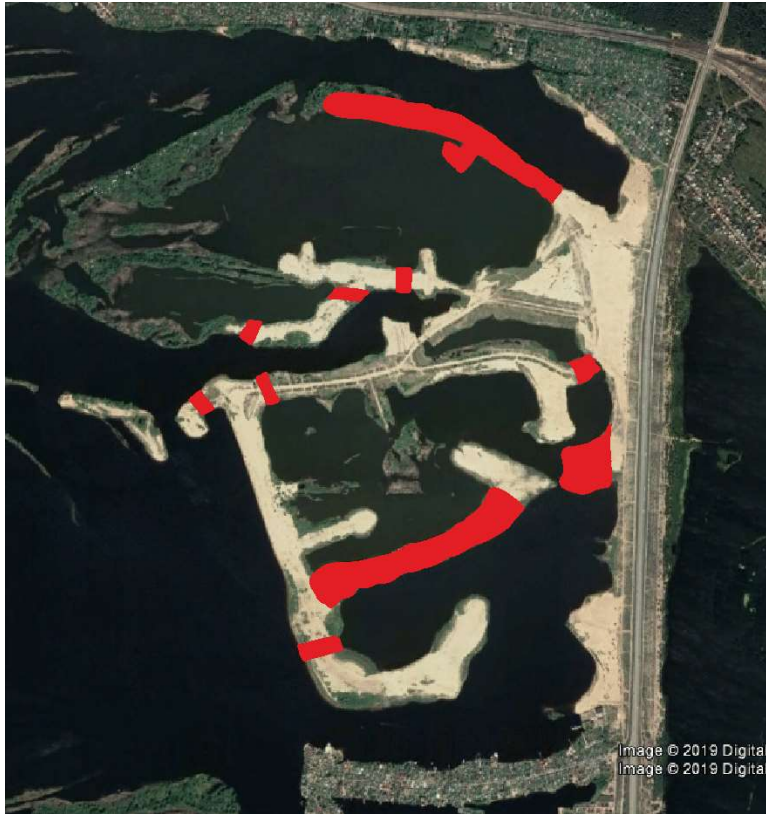
Fig. 6 : Places for Clearing the Channels (Colored in Red).

To restore the previously existing water exchange, the authors of project recommend the clearing of channels in 10 locations (Fig. 6).

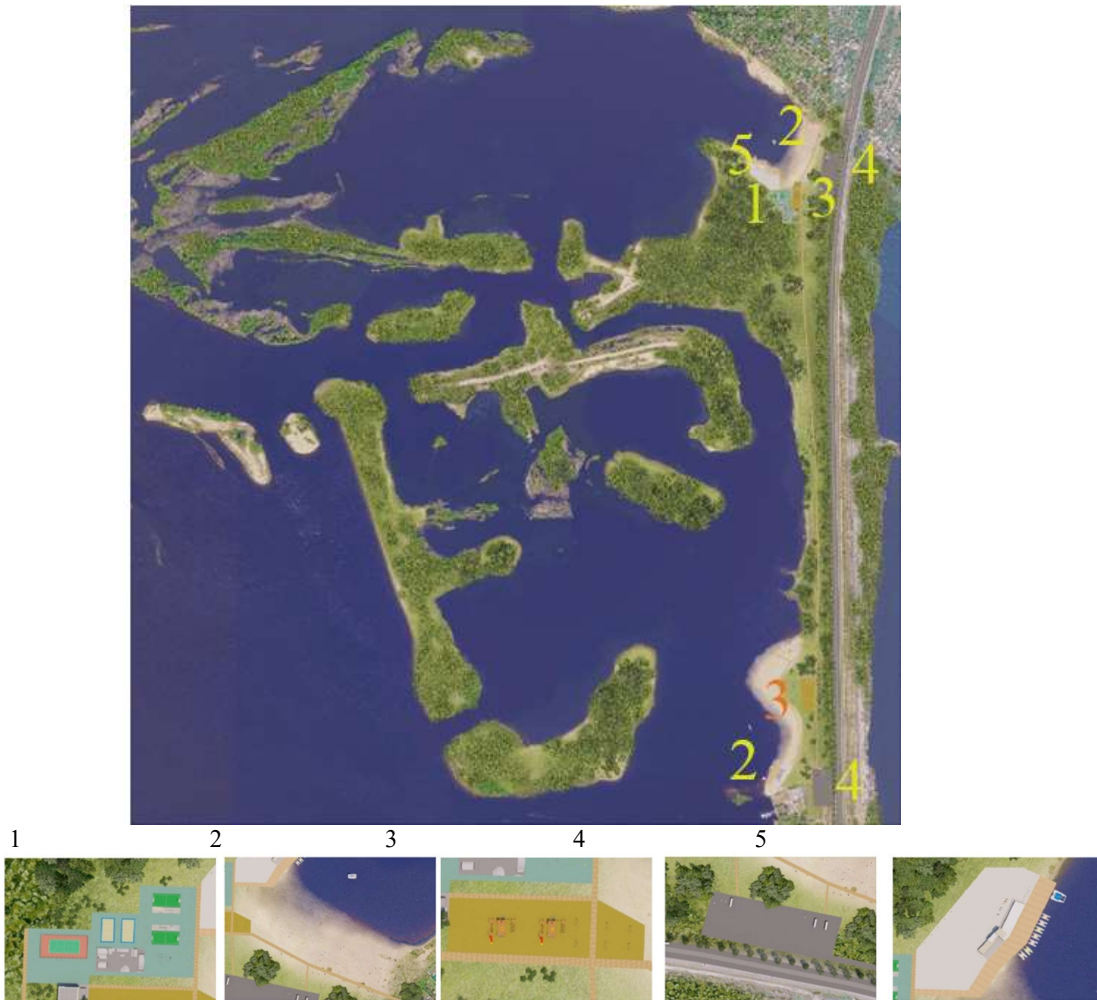
Fig. 7: The Master Plan of Landscaping Project. (1 - Zone of Active Recreation; 2 - Beach; 3 - Children's Playground; 4 - Zone of Car Parking; 5 - Zone of Boat Rental).

At the next stage, the improvement of the coastal territory is planned (Fig. 7). The project, developed by us, includes various functional areas: places for short-term stay and rest of people; areas of quiet and active recreation; beach recreation; areas for children; rental areas; as well as the creation of developed network of highways and byways with hard surface; street lighting; parking area.
